Automatic Transmission - Fluid Leak
TRANSMISSION & CLUTCH
TC003-00

Title:
AUTOMATIC TRANSMISSION FLUID LEAK

Models:
'00 Celica GTS

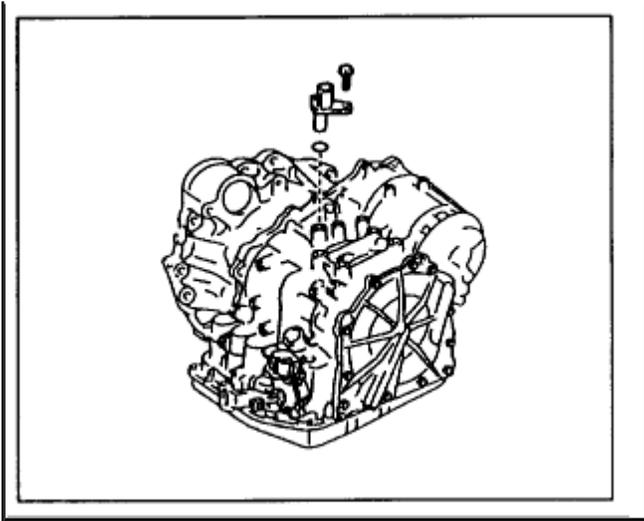
In some cases the U240E transaxle in the 2000 model year Celica GTS may leak automatic transmission fluid from the counter gear speed sensor bolt hole. The repair procedure for this condition is described in this bulletin.

1. Remove the counter gear speed sensor and 'O'-ring.
2. Clean the surfaces of the retaining bolt and the bolt hole.

- A. Blow compressed air into the bolt hole to remove automatic transmission fluid.
 - B. Clean the bolt hole by using a spray cleaner (brake cleaner, etc.) into the hole.
 - C. Clean the bolt threads with a wire brush, then use a spray cleaner to remove debris.
 - D. Repeat the above steps (A through C) 2 to 3 times.
3. Install the speed sensor.
