SUNSHADE TRIM REPLACEMENT

BO007-00

'00 MY Celica

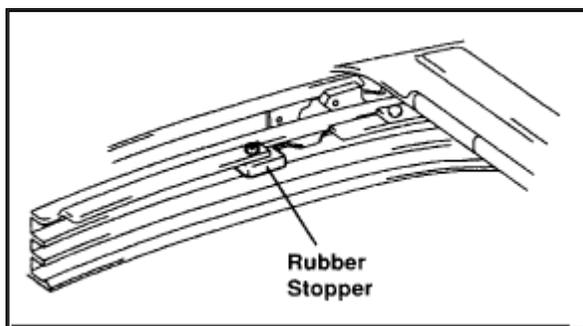
1. Remove the sliding roof panel.
 - A. Remove the 4 screws that secure the sliding roof panel.
 - B. Pull the sliding roof panel upward to remove it.

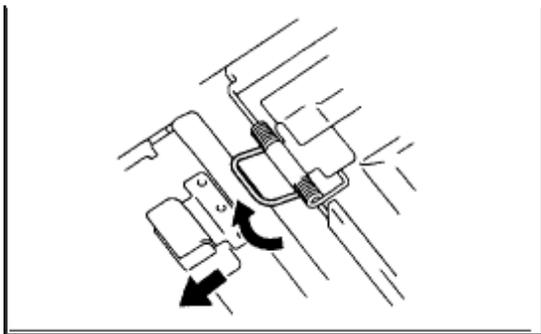
2. Remove the rubber stopper.
 - A. Remove the screw and rubber stopper on both sides.
3. Remove the No.1 and No.2 sunshades.

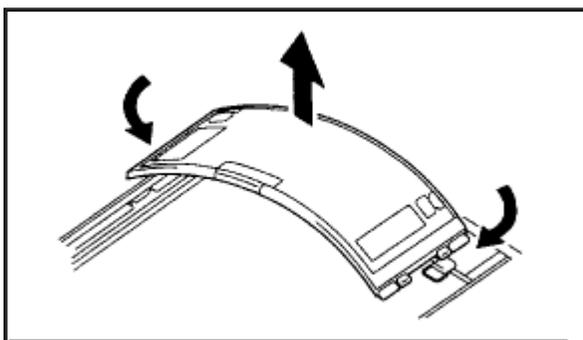
A. Release the spring between the No.1 and No.2 sunshades on both sides.

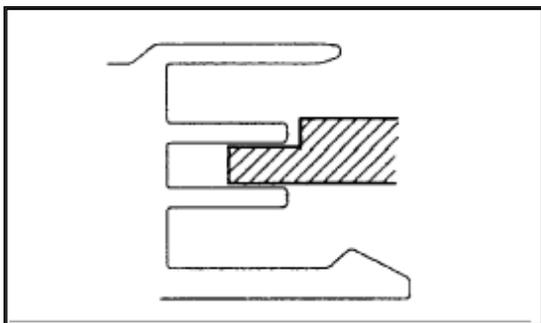
B. Bend the No.1 sunshade in the center to remove it as shown.

C. Repeat the same procedure for the No.2 sunshade.

NOTE: Bending the sunshade excessively may cause damage.

HINT: When re-installing the sunshade, insert it into the slider rail as shown.
