Tachometer/Speedometer Needle Fluctuation

EL008-99

'00 Celica

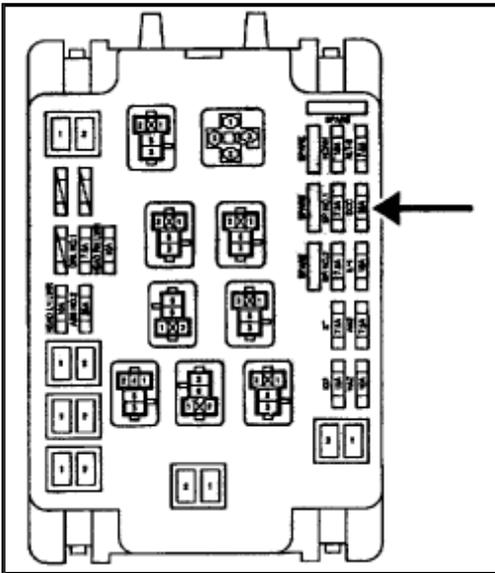
If a vehicle exhibits this condition, check that the DCC 25 amp fuse is in the Junction Block as shown.
